DOT/FAA/AR-08/45

Development of a Scoring Algorithm for Flight Crew Intervention Credit in System Safety Assessments

November 2008

Final Report

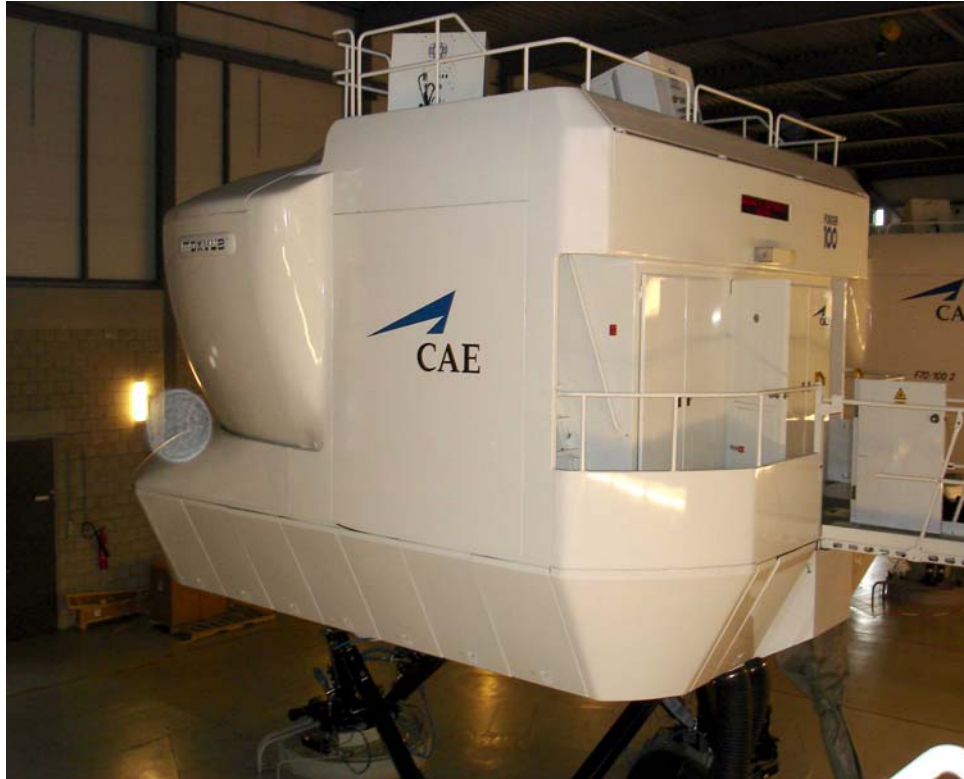
Figure 14. Simulator Used for the Experiment

The experiment was conducted in a Fokker 100 level-D training simulator at CAE in Hoofddorp, The Netherlands (figures 14 and 15). All experiments were performed under simulated daylight conditions. The motion system was engaged, and a video camera recorded the actions of both pilots. Each session started with a takeoff in which the experiment pilot was pilot flying. When the experiment pilot was sufficiently familiar with the aircraft (typically after 10-15 minutes), the first failure was presented. When the failure handling was completed, a short debrief was conducted by the observers. During the debriefing, the simulator operator prepared the simulator for the next failure case. Each simulator session lasted 3.5 hours, which included a short break approximately halfway through the session.

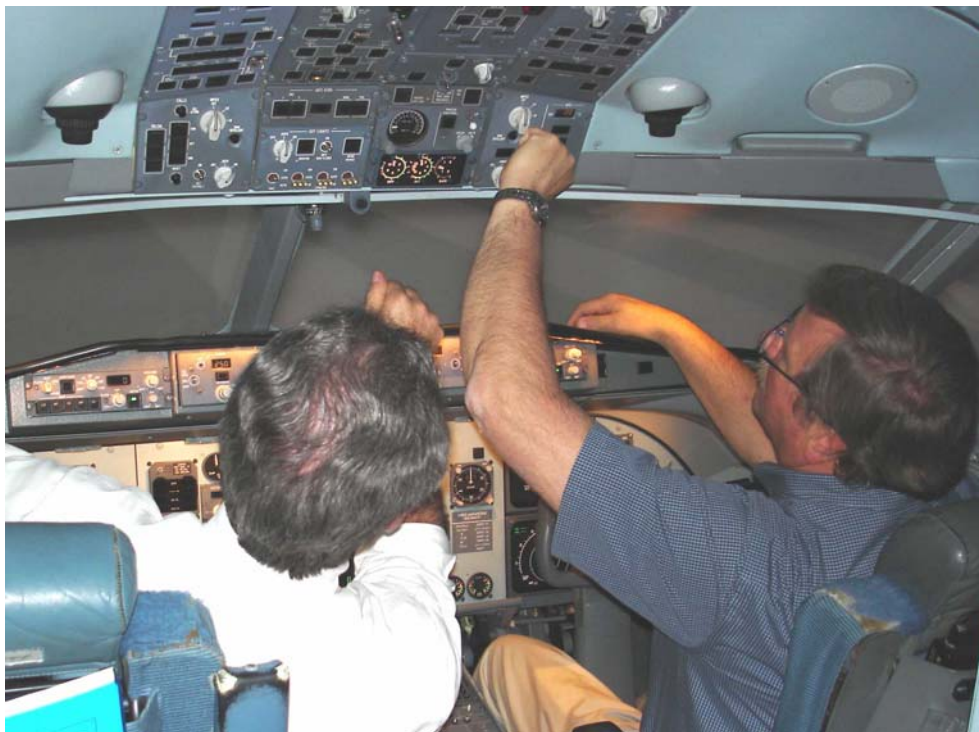
Figure 15. Starting the APU During the Simulator Experiment
